White Horse Park Association
Berlin, MD

Report #: 55451-0
Beginning: April 1, 2026
Expires: March 31, 2027

RESERVE STUDY
Update "With-Site-Visit"

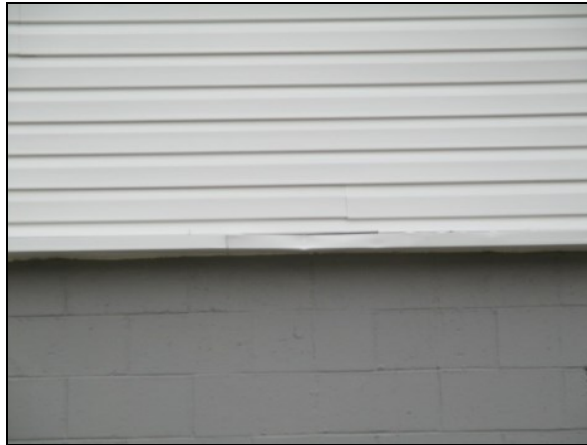
Comp #: 2356 Vinyl Siding/Trim/Soffit - Replace

Comments: The vinyl siding is in fair condition, showing minor to moderate fading of color and more surface wear and cracking, especially in more exposed areas or elevations. Some curling or cupping of individual sections may be evident.

No view of the underlying waterproofing was undertaken as part of this limited visual review. In our experience, vinyl siding will fade over the years and when replacing pieces, it may be difficult to match the faded color. The useful life expectancy shown below is for financial planning purposes only. We recommend that the Client consult with a qualified contractor/engineer to evaluate the siding, and the critical underlying waterproofing (building paper or house wrap) as the remaining useful life approaches zero. In some cases, remaining useful life extension may be warranted based on the evaluation of performance of the underlying waterproofing. Cost estimates shown here assume that siding will be replaced with a similar vinyl material again. If other siding types are considered for replacement, the Reserve Study should be updated accordingly during future update engagements to incorporate the most current estimates and information available at that time.

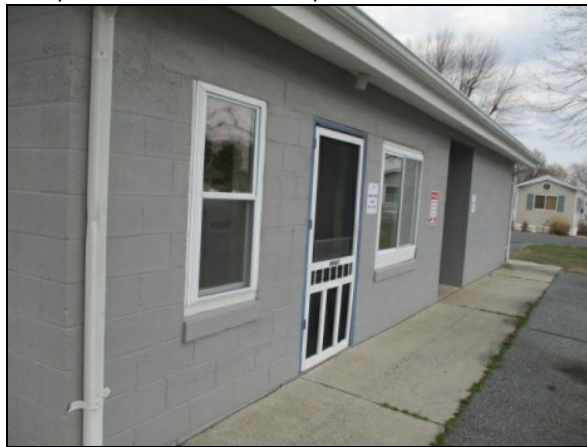
Comp #: 2367 Windows & Doors - Replace

The windows and doors are in fair condition, showing normal signs of wear for their age, including more surface wear on the framework and hardware, but no advanced corrosion or other concerns. They remain functional and are aging normally, though more advanced technology may be available.

Unless otherwise noted, this component refers only to common exterior windows and doors. All are assumed to have been compliant with applicable building codes at time of installation. Inspect regularly for leaks and cracks around frame and repair as needed. Clean tracks and ensure hardware is functional to prevent accidental damage during opening/closing. With ordinary care and maintenance, useful life is typically long but often difficult to predict. Many factors affect useful life including quality of window currently installed, waterproofing details, exposure to wind and rain, etc. Individual windows and doors should be replaced as an Operating expense if damaged or broken. We recommend replacement at the approximate interval shown below based on consideration of installation/replacement dates, evident conditions, and/or our experience with similar Clients. Unless otherwise noted, cost estimates are based on replacement with current impact-resistant models.

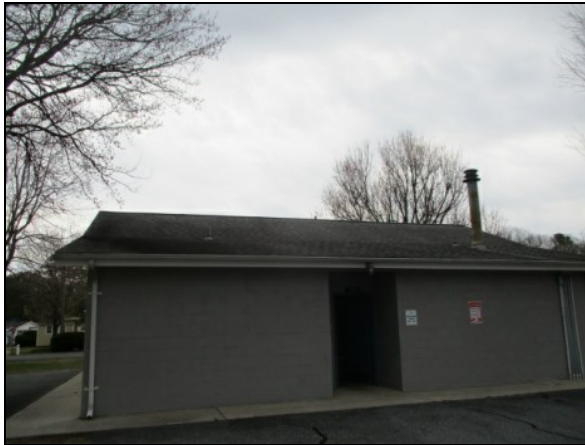
Comp #: 2381 Roofing and Gutters - Replace

Comments: The asphalt shingle roofs are in fair condition, showing normal signs of wear and deterioration, including some loss of granule cover and light to moderate curling or lifting, especially in the most exposed areas. Overall, the roof is aging normally. Includes 160 LF of gutters.

As routine maintenance, many manufacturers recommend inspections at least twice annually and after large storm events. Promptly replace any damaged/missing sections or conduct any other repair needed to ensure waterproof integrity of roof. Keep roof surface, gutters and downspouts clear and free of moss or debris. Moss growth can decrease the life of the roofing shingles and should be removed promptly. We recommend having roof inspected in greater detail (including conditions of sub-surface materials) by an independent roofing consultant prior to replacement. If the roof has a warranty, be sure to review terms and conduct proper inspections/repairs as needed to keep warranty in force. Dimensional shingles typically have longer useful lives and are generally considered to be more valuable from an aesthetic standpoint. We recommend budgeting to replace with dimensional shingles upon failure. Also known as architectural shingles, these types of roofs are typically more durable and wind-resistant than 3-tab shingles. Remaining useful life is based on consideration of installation/replacement date, evident visual conditions, and/or repair history provided by the Client. Unless otherwise noted, costs shown here assume that only a minimal amount of substrate/decking repairs or replacement will be required. For very old roofs or those with significant leak problems, additional repair costs may be incurred.

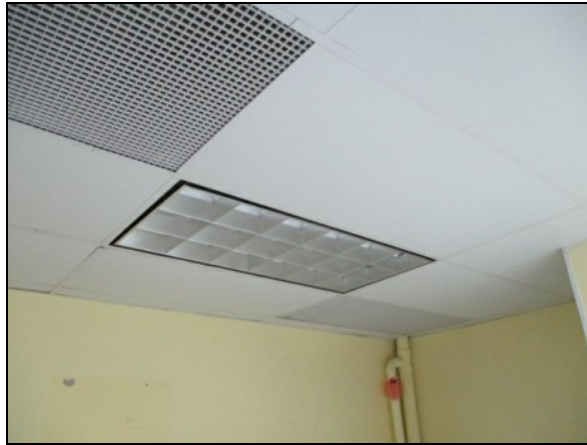
Comp #: 2719 Drop Ceiling - Replace

Comments: Suspended ceiling systems in fair condition generally display only routine signs of physical deterioration. The appearance remains consistent across all areas, indicating that while there may be minor wear and tear, the system remains functionally and visually acceptable. Includes 14 Ceiling lights.

Suspended ceiling systems should have a very long life under most circumstances. Individual panels should be replaced as needed through the Operating budget. Based on evident conditions, original installation date, and prior project history provided during this engagement, we recommend planning on complete replacement at the approximate interval shown below. Replacement will restore aesthetic value in the common areas. Best practice is to coordinate this work with other interior finish projects (painting, flooring, etc.) whenever possible in order to minimize downtime and maintain consistency. Unless otherwise noted, cost estimates shown below assume replacement with a similar type to the existing system.

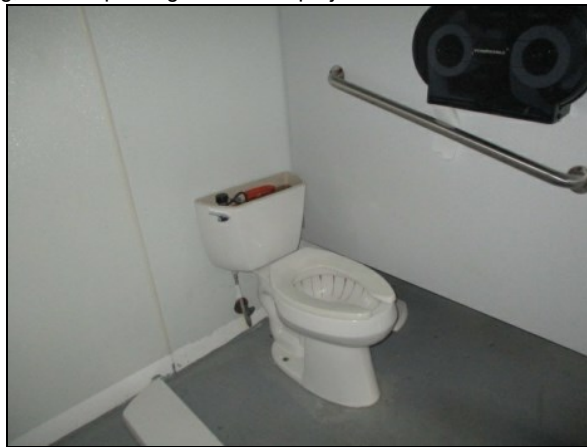
As routine maintenance, inspect regularly and perform any needed repairs promptly utilizing general Operating funds. Typical remodeling project can include some or all of the following: replacement of plumbing fixtures, partitions, countertops, lighting, flooring, ventilation fans, accessories, décor, etc. Best practice is to coordinate this project with other amenity areas, such as kitchens or other amenity rooms. Remaining useful life is based on consideration of materials, evident conditions, and/or remodeling/renovation history provided during the engagement. Costs can significantly vary based on an anticipated scope of work as well as materials chosen for remodeling/renovation. Unless otherwise noted, estimates shown are based primarily on light to moderate cosmetic remodeling, not complete "gut" remodel projects.

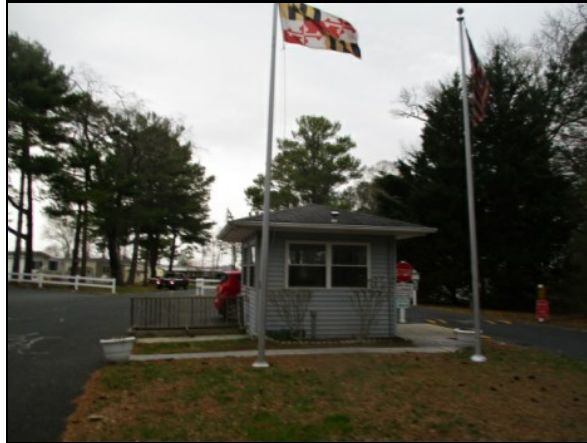
We noted that the guardhouses are in fair condition, showing normal signs of wear and tear, and curb appeal is affected at this stage. All building envelope and mechanical components are in serviceable condition. If present, interior furnishings may be dated or inadequate.

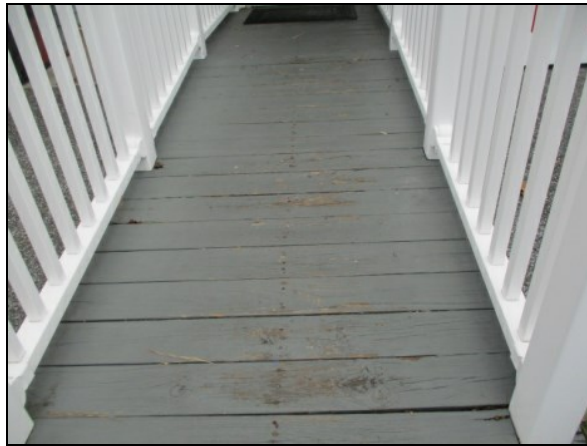
Comments: Deck surfaces in poor condition exhibit more advanced signs of weathering and surface wear. At this stage, hardware often shows larger amounts of rust or corrosion, and there may be trip hazards or other safety concerns present. Continued prolonged exposure may lead to structural concerns. The appearance is inconsistent and does not uphold good aesthetic standards.

Decks should be inspected, cleaned, and repaired regularly as part of the Clients Operating budget. Any safety hazards (such as lifting boards, splintering, trip hazards, lifting nails/screws, etc.) should be repaired immediately. Depending on the material used, useful life can sometimes be prolonged by using sealers or other coatings to provide additional protection from the elements. Unless otherwise noted, funding recommendations assume replacement with similar decking as currently in place. Funding recommendation may also include an allowance for additional repairs that are often required when these types of structures are resurfaced. However, this component should be re-evaluated during future Reserve Study updates based on the most current information available at that time.

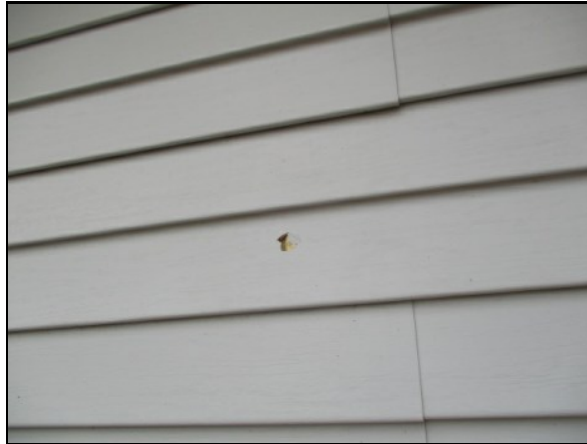
Comp #: 2356 Vinyl Siding/Trim/Soffit - Replace

Comments: The vinyl siding is in fair condition, showing minor to moderate fading of color and more surface wear and cracking, especially in more exposed areas or elevations. Some curling or cupping of individual sections may be evident.

No view of the underlying waterproofing was undertaken as part of this limited visual review. In our experience, vinyl siding will fade over the years and when replacing pieces, it may be difficult to match the faded color. The useful life expectancy shown below is for financial planning purposes only. We recommend that the Client consult with a qualified contractor/engineer to evaluate the siding, and the critical underlying waterproofing (building paper or house wrap) as the remaining useful life approaches zero. In some cases, remaining useful life extension may be warranted based on the evaluation of performance of the underlying waterproofing. Cost estimates shown here assume that siding will be replaced with a similar vinyl material again. If other siding types are considered for replacement, the Reserve Study should be updated accordingly during future update engagements to incorporate the most current estimates and information available at that time.

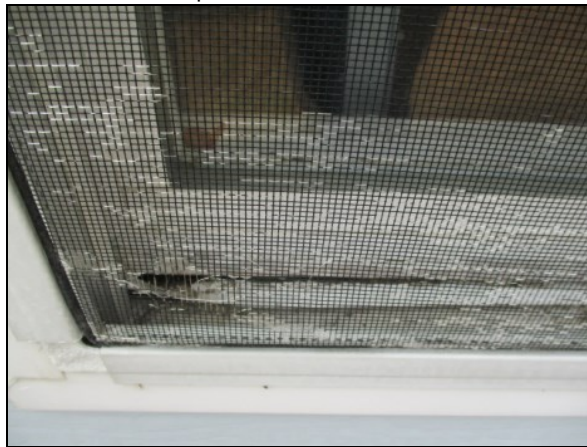
Comp #: 2367 Windows & Doors - Replace

The windows and doors are in good condition, exhibiting only minor, routine signs of wear and age. Frames are intact with no significant pitting or surface wear. All moving parts are functional, and the glass is clear and free from damage.
